Getting the Best Alignment Possible

Using laser alignment on a tough vertical condensate pump application saved valuable downtime and avoided a lot of frustration.

Pumps and Processes Staff with Alan Luedeking, Mgr., Technical Support & Training, Ludeca, Inc.

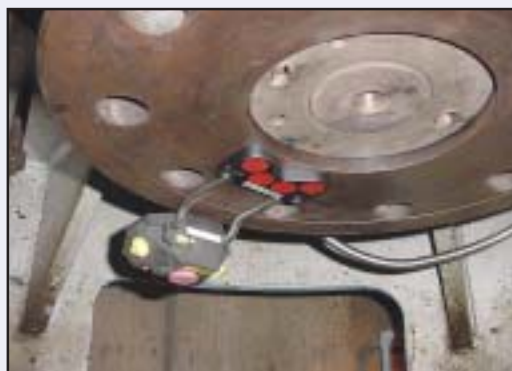
Photo 1. The laser emitter was installed on the motor shaft. This was done by attaching a magnetic bracket with offset support posts to the face of the rigid motor coupling.

Since the pump shaft cannot be turned when uncoupled and resting on the bottom, the laser readings were taken using the "static" measurement mode, which permits a reading to be taken in any cardinal or subcardinal position. Additionally, this mode disables the internal automatic inclinometer, which is necessary in a vertical shaft orientation, as the inclinometer is gravity operated. The laser and receiver components are rotated separately. Because the motor shaft can be rotated freely, the laser emitter was installed on this shaft. This was done by attaching a magnetic bracket with offset support posts to the face of the rigid motor coupling, as shown in Photo 1.

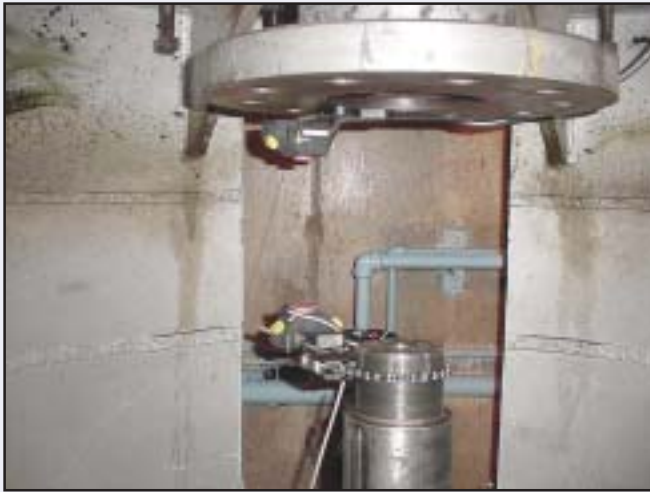
Photo 2. The receiver is mounted on the pump shaft using a standard chain bracket.

The receiver is mounted on the pump shaft, normally using a special magnetic sliding bracket, since the pump shaft cannot be turned. However, in this case a non-magnetic shaft prevented this, so the standard chain bracket was used, as shown in Photo 2. Care was taken not to hurt the threads on the shaft. The laser beam was adjusted and an initial reading was taken.
