Alignment Application:

## Bearing race measurement following crankshaft bearing damage

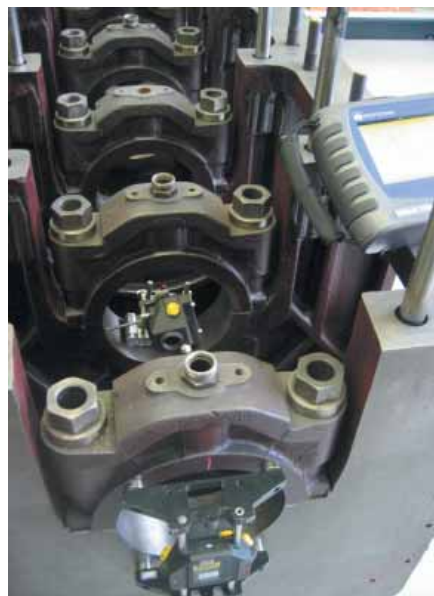
Fig.1: Laser equipment for monitoring the bearing saddles

With the BORALIGN® laser-optical measurement system and suitable accessories, a bearing race can be measured relatively quickly directly in the ship after the crankshaft is removed. New engine designs with hanging crankshafts are also easy to measure with this system, even in a half shell that is facing downward.

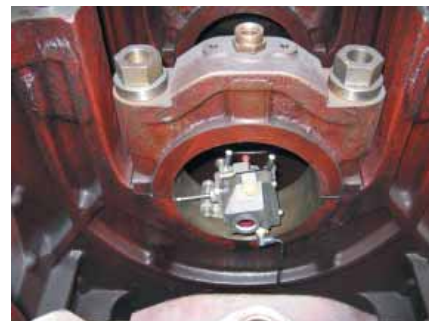
Fig.2: The laser sensor, which can be rotated inside the bore

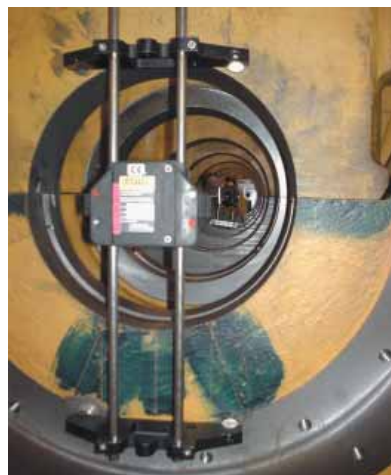
Fig.3: The laser transmitter with magnetic mounts
